CARR-185

Site of Masonic Hall, Church of God & Parsonage

CARR-185 Masonic Hall, Church of God Church and Parsonage (site)

FIELD SHEET--HISTORIC RESOURCES SURVEY

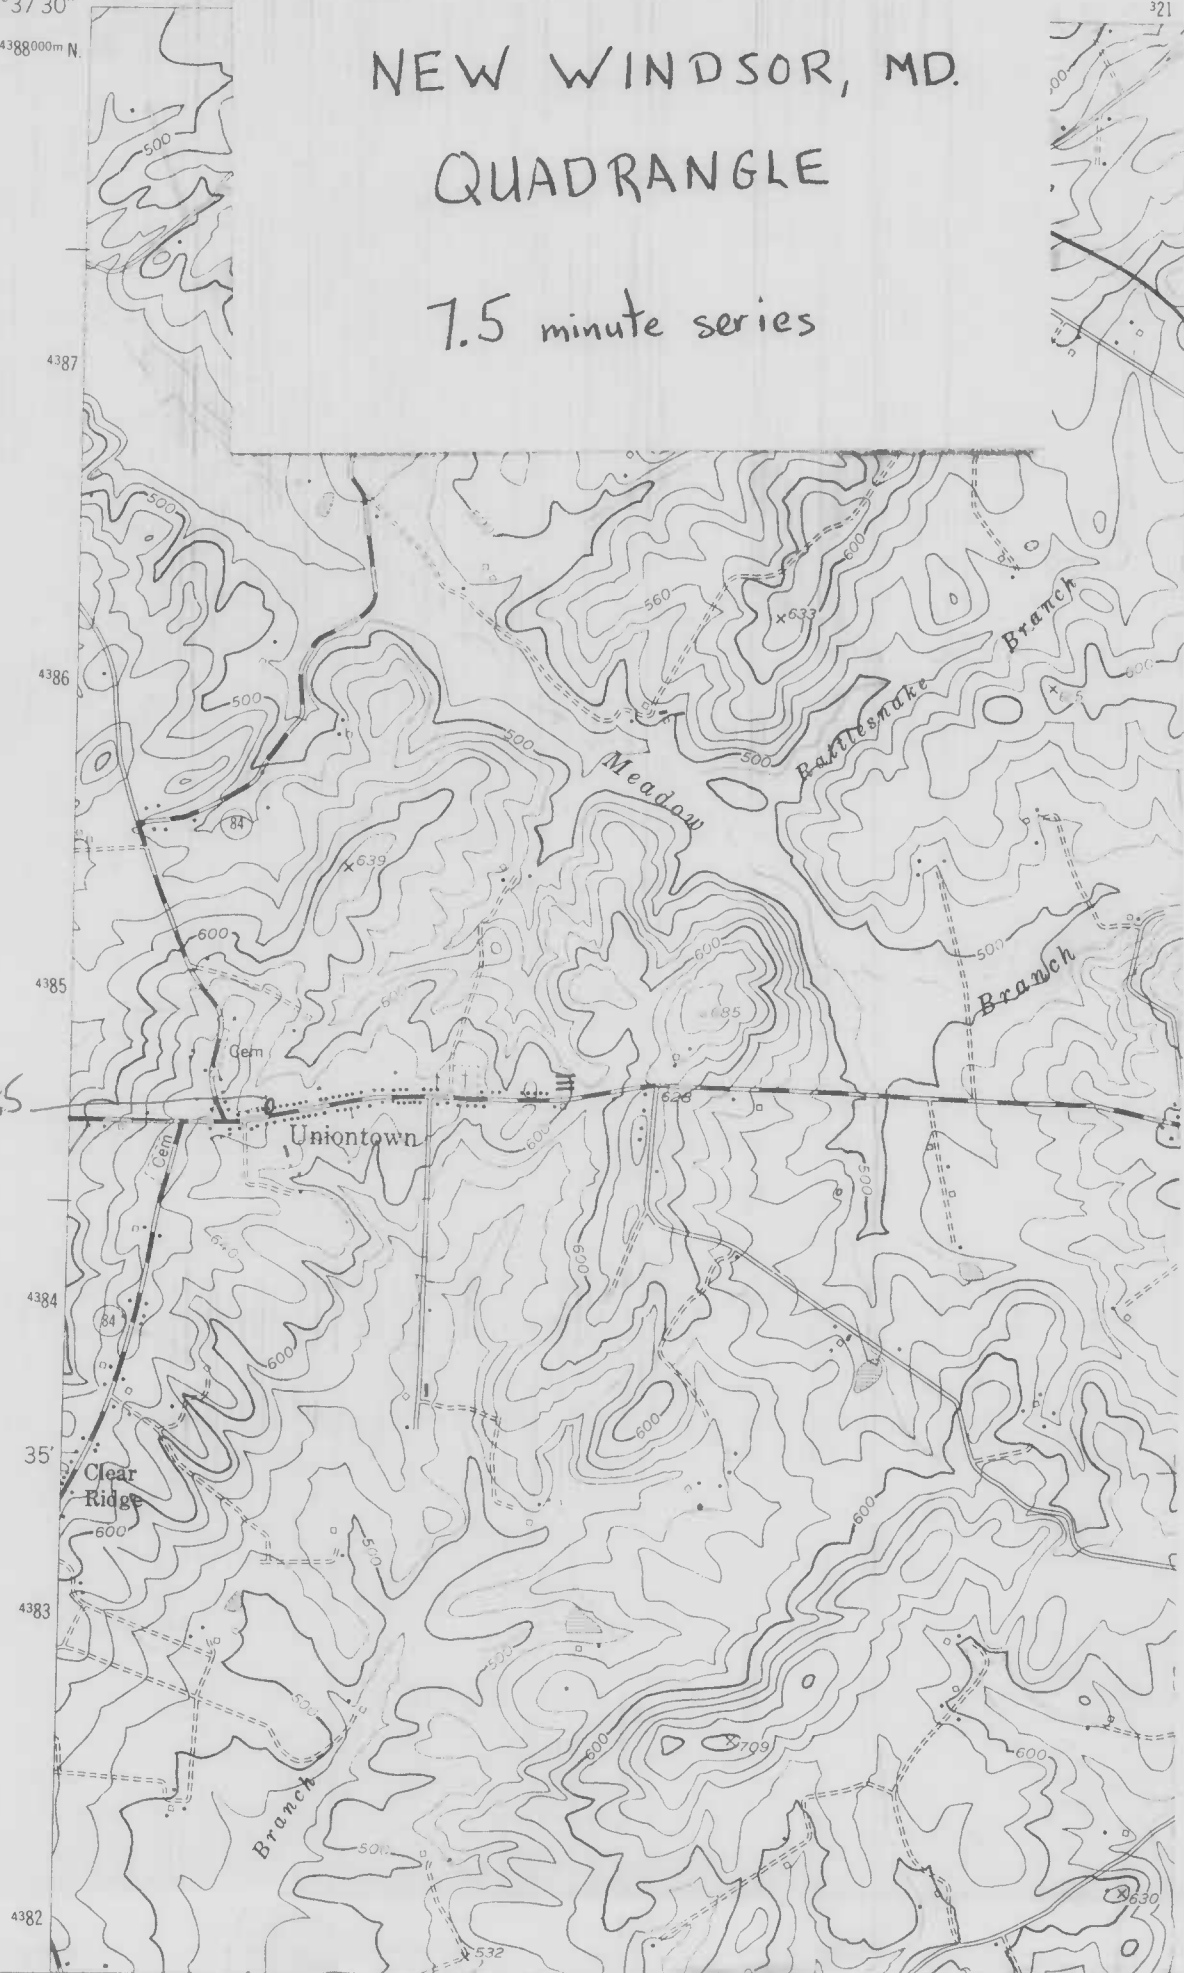
1. CARR-185 Uniontown Church of God
2. Carroll County, Maryland
3. Joe Getty
4. 1959
5. Md. Historical Trust, Annapolis Md.
6. Copy of photo in HSCC collection
7. 2/2
